**AB 2766/MSRC Alternative Fuel Infrastructure Program Contract
CONTRACT NO. MS12078
Penske Truck Leasing Co., L.P.
October 2015**

**2727 South Santa Fe Avenue
Los Angeles, CA 90058**

Final Photos

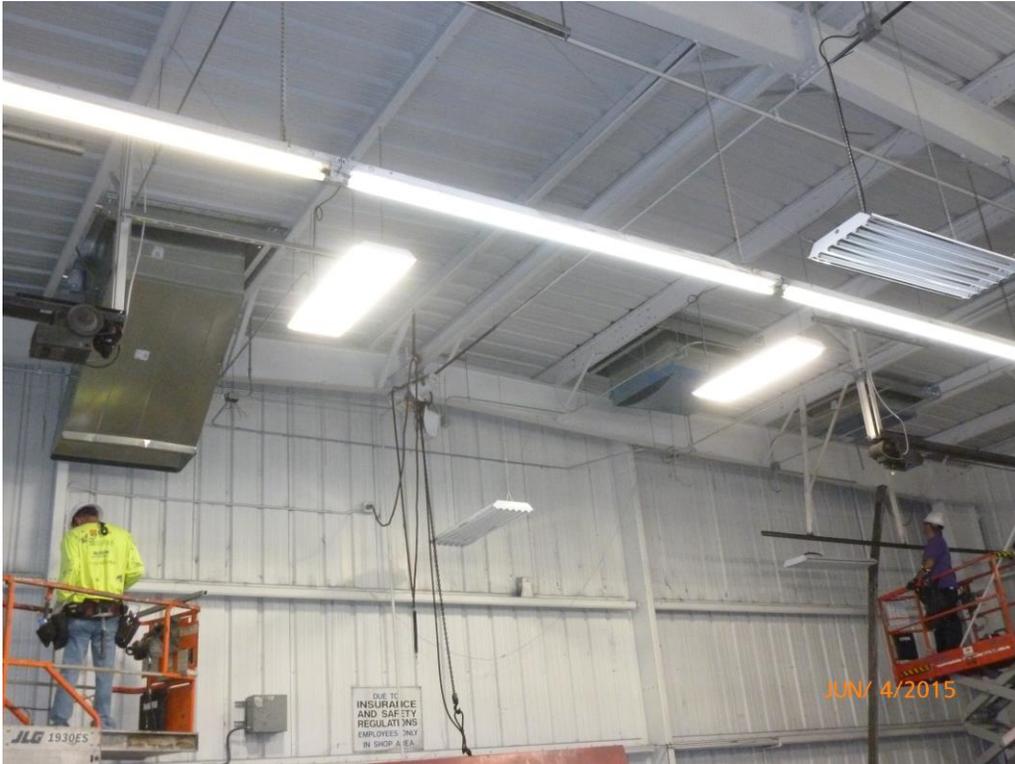
1. Appears to be exhaust ducting for conventional fuels

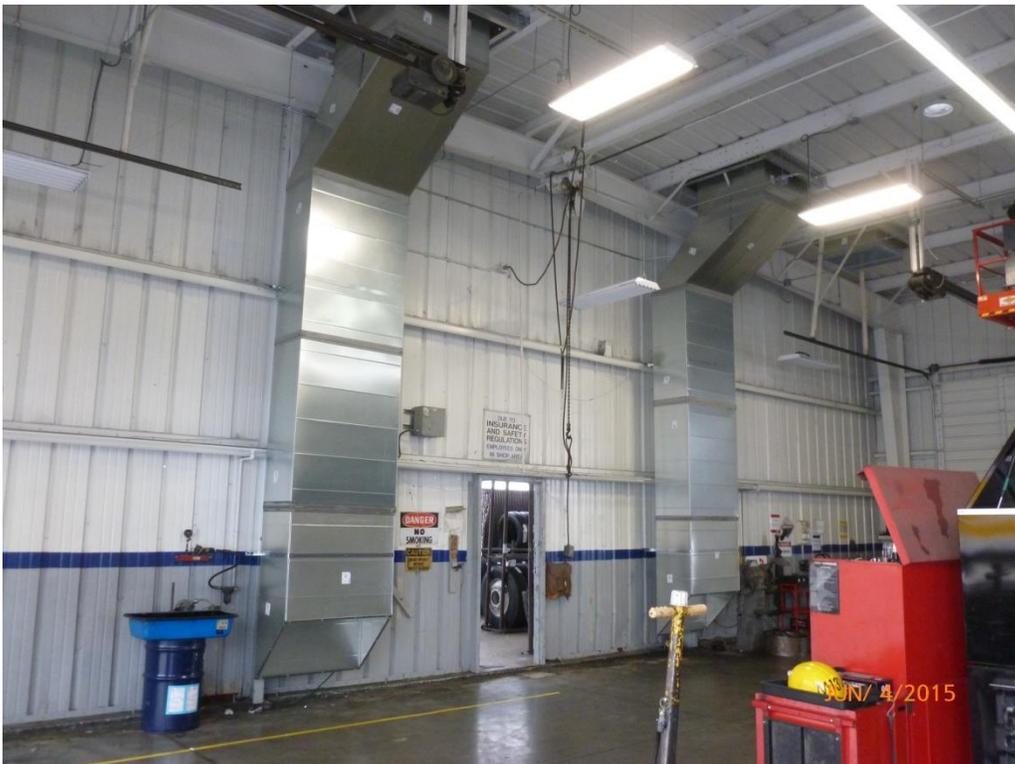
2. Appears to be completion of the exhaust ducting for conventional fuels

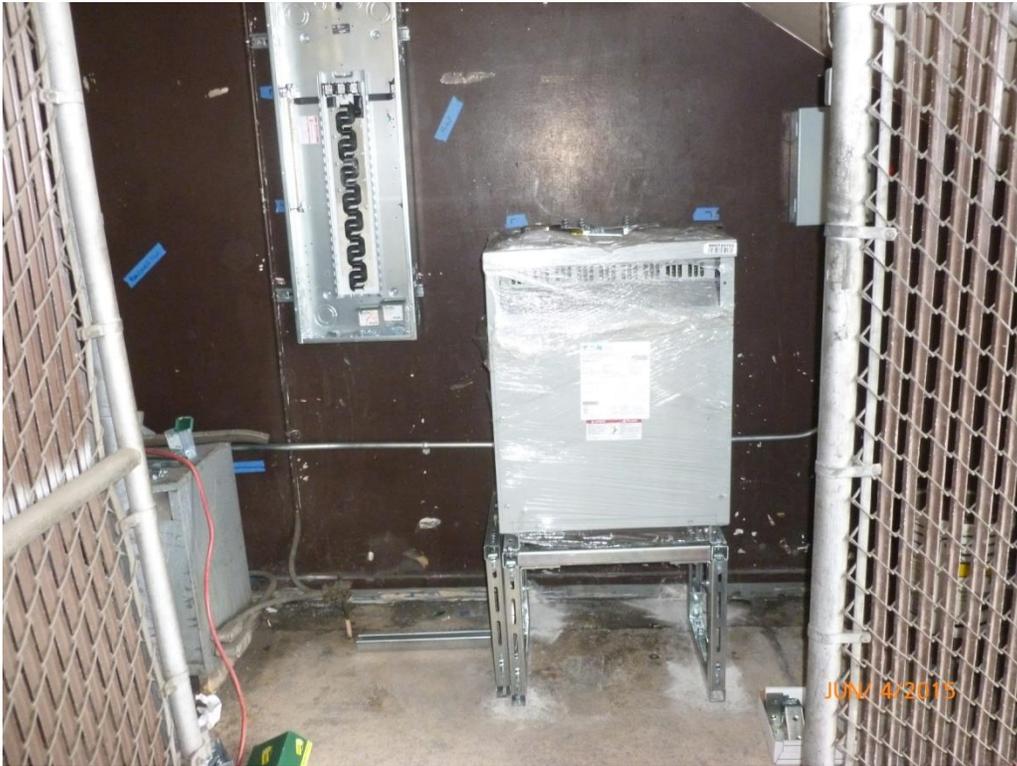
3. Possibly battery backup for alarms, fans, etc. in the event of a power outage

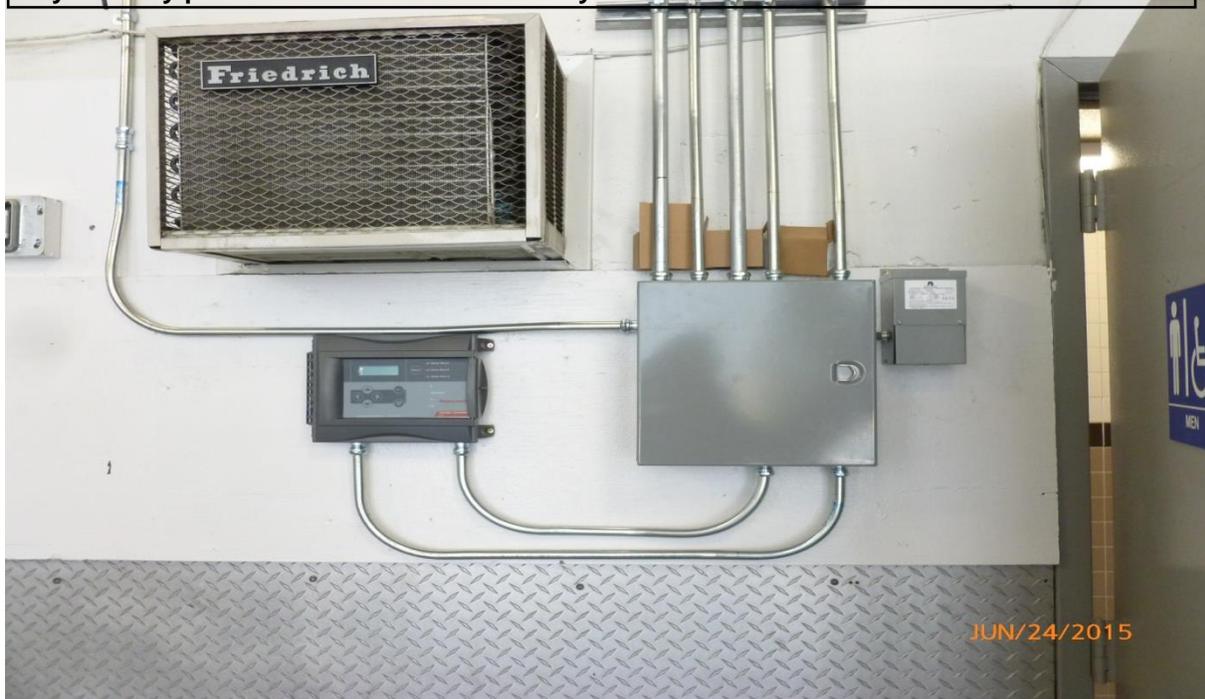
4. Appears to be part of the detection and alarm system but cannot confirm whether it is CO only or if any part of the methane detection system is included.

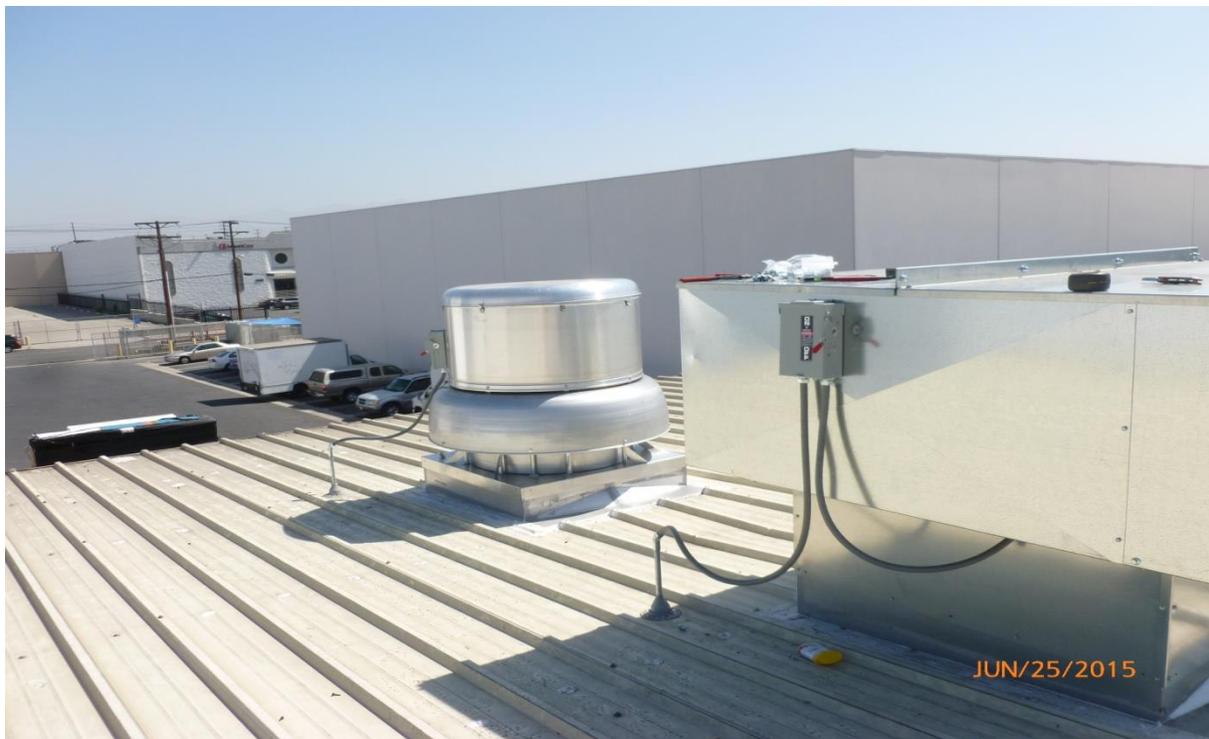
5. Appears to be exhaust fan for conventional fuels

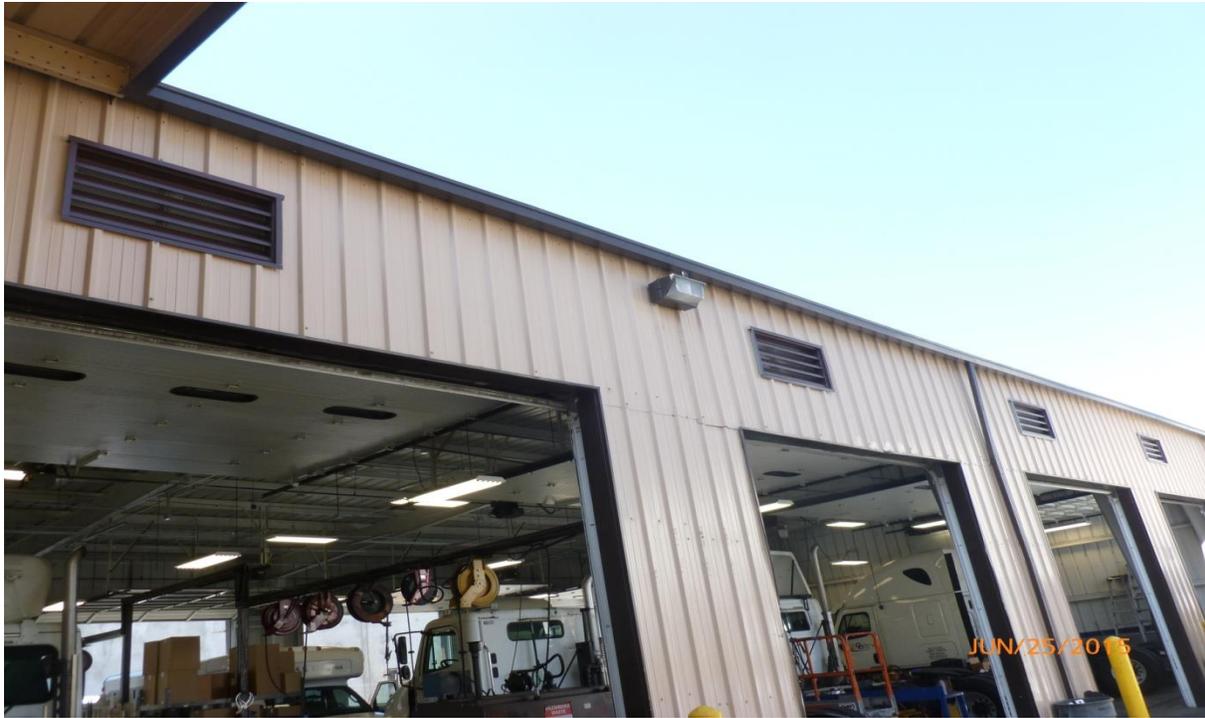
6. The louvers do not appear to be associated with Task 4
